Occurrence # 05-016

**OCCURRENCE REPORT**

Re: Trails North - Jan. 2005 : Spill Response Information

Re. Trails North Car & Truck Stop – Gasoline Spill January 2005

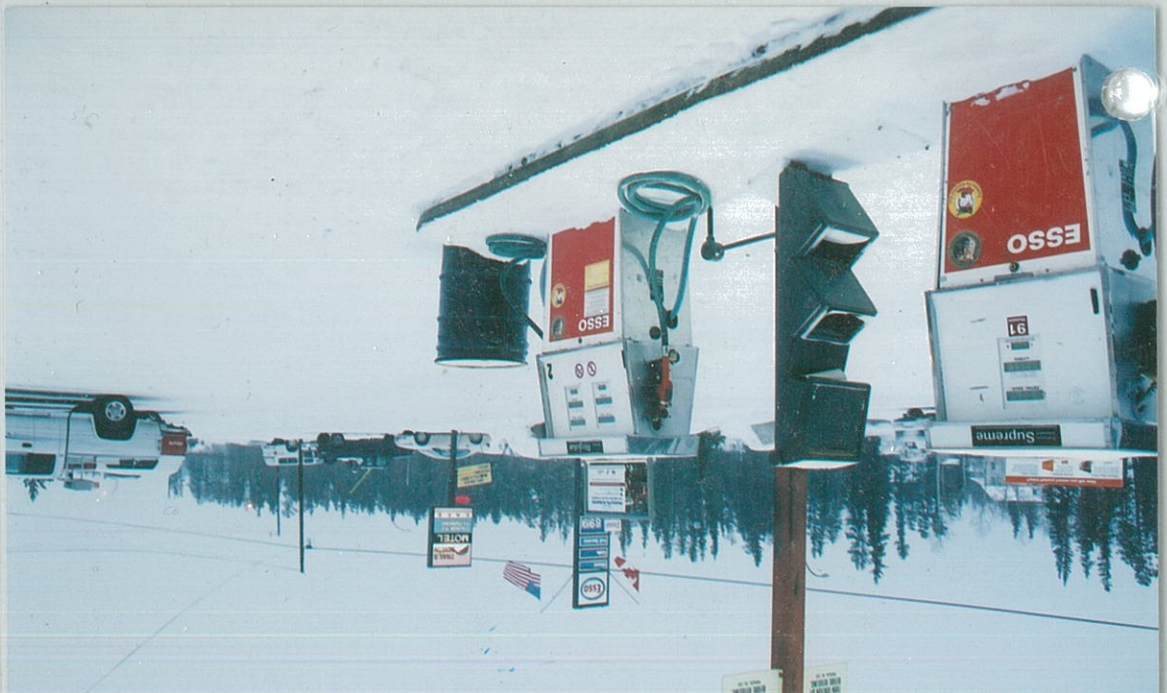
PHOTO #: 1

Met with owner, Dave GEOGHEGAN. Last weeks cold weather caused the failure of gasket(s) in Pump #2. Inventory records identified a loss and a consultant (GROUNDTRAX) was hired. The gasket(s) was repaired and approx. 200L of gasoline was recovered from a reservoir under the pump. It is estimated that another 1800L escaped the reservoir and entered the natural soils beneath the pump. GROUNDTRAX will be continuing with the assessment of the site. No free product on the surface, no odors detectable.

DESCRIPTION: Pump #2, site of Spill #05-01

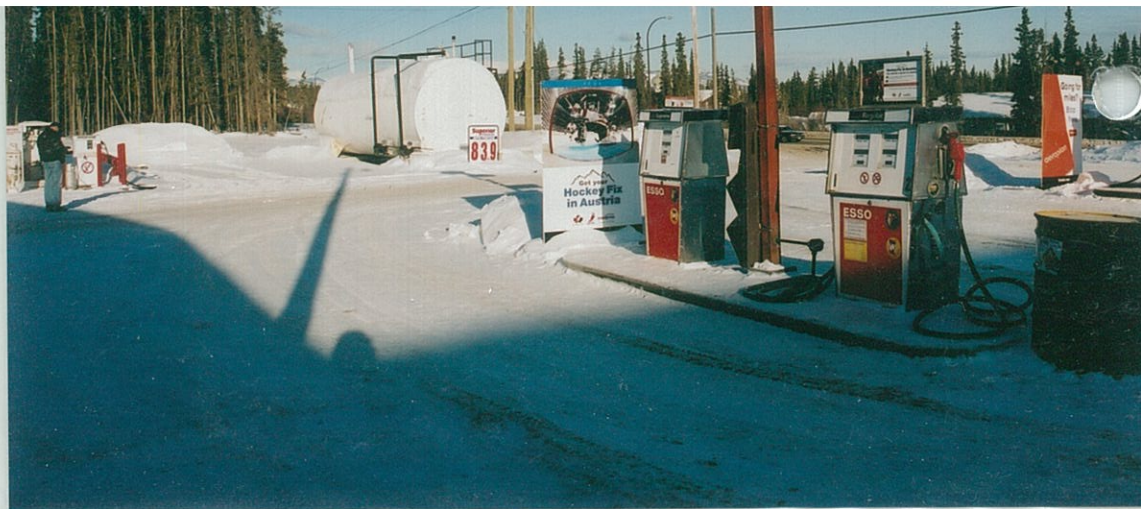
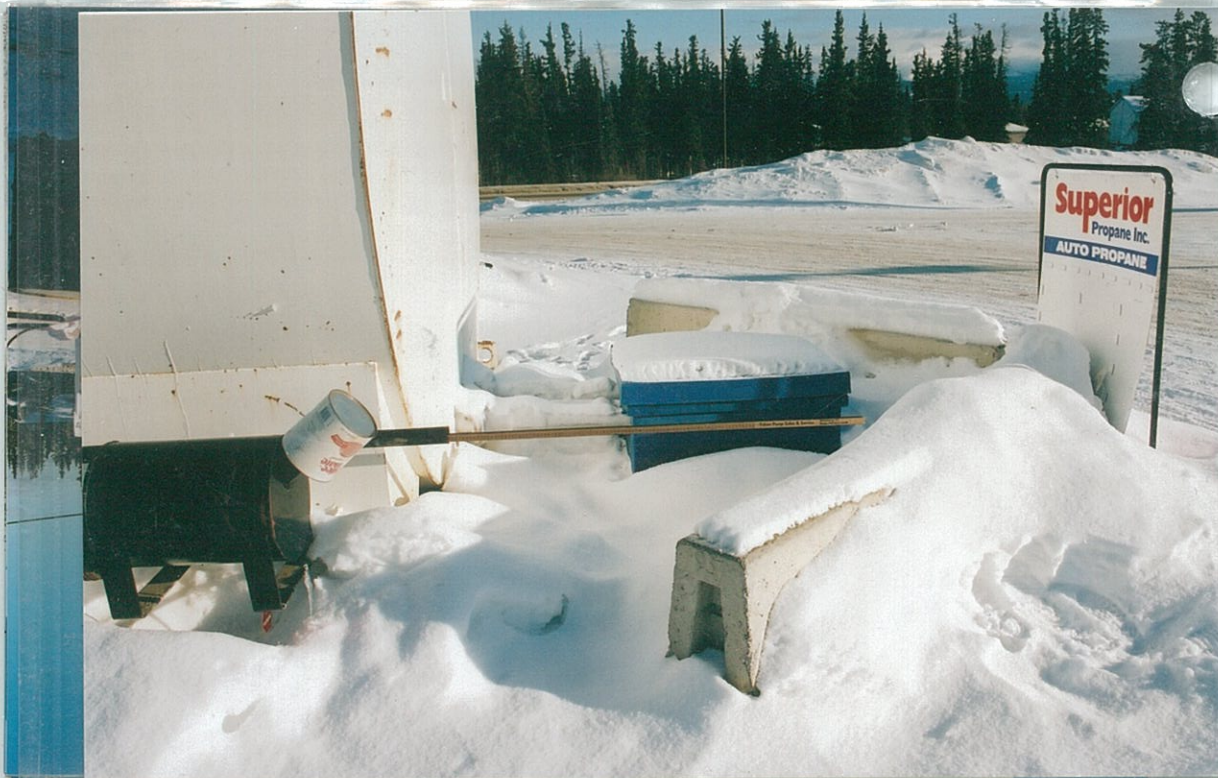
TIME: 1112 **PHOTO #:** 2

DESCRIPTION: Piping assembly, south end of UST,
from W

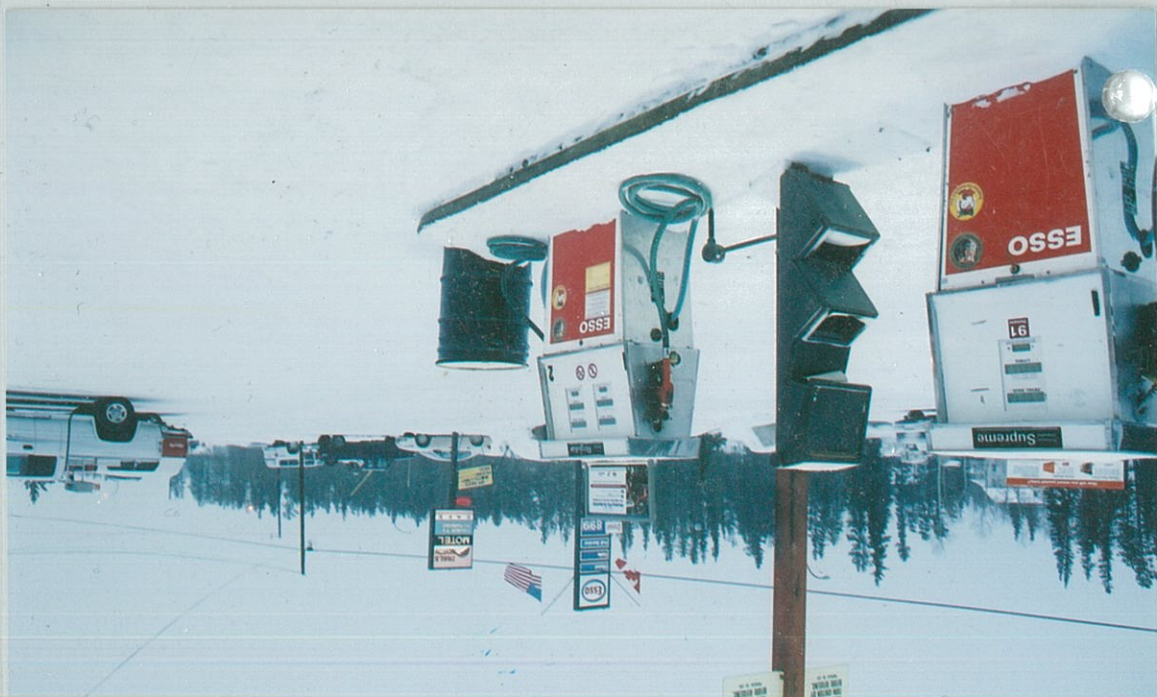
PHOTO #: 1

DESCRIPTION: Pump #2, site of Spill #05-01
