Environment Act
INSPECTION REPORT

Permit No.: 60-010-01

Inspection Report No.: 2022-068

PERMITTEE: Yukon Energy Corporation		
PERSON CONTACTED: Gary JONES & Travis RITCHIE	ACCOMPANIED BY: Gary JONES	INSPECTED BY: Emily SESSFORD
MAILING ADDRESS: Box 5920, Whitehorse, YT Y1A 6S7		
LOCATION: 413 Campbell Street, Faro, YT Y0B 1K0		
INSPECTION DATE & TIME: October 14, 2022 13:00	PERMIT EXPIRY DATE: December 31, 2031	LAST INSPECTED: N/A

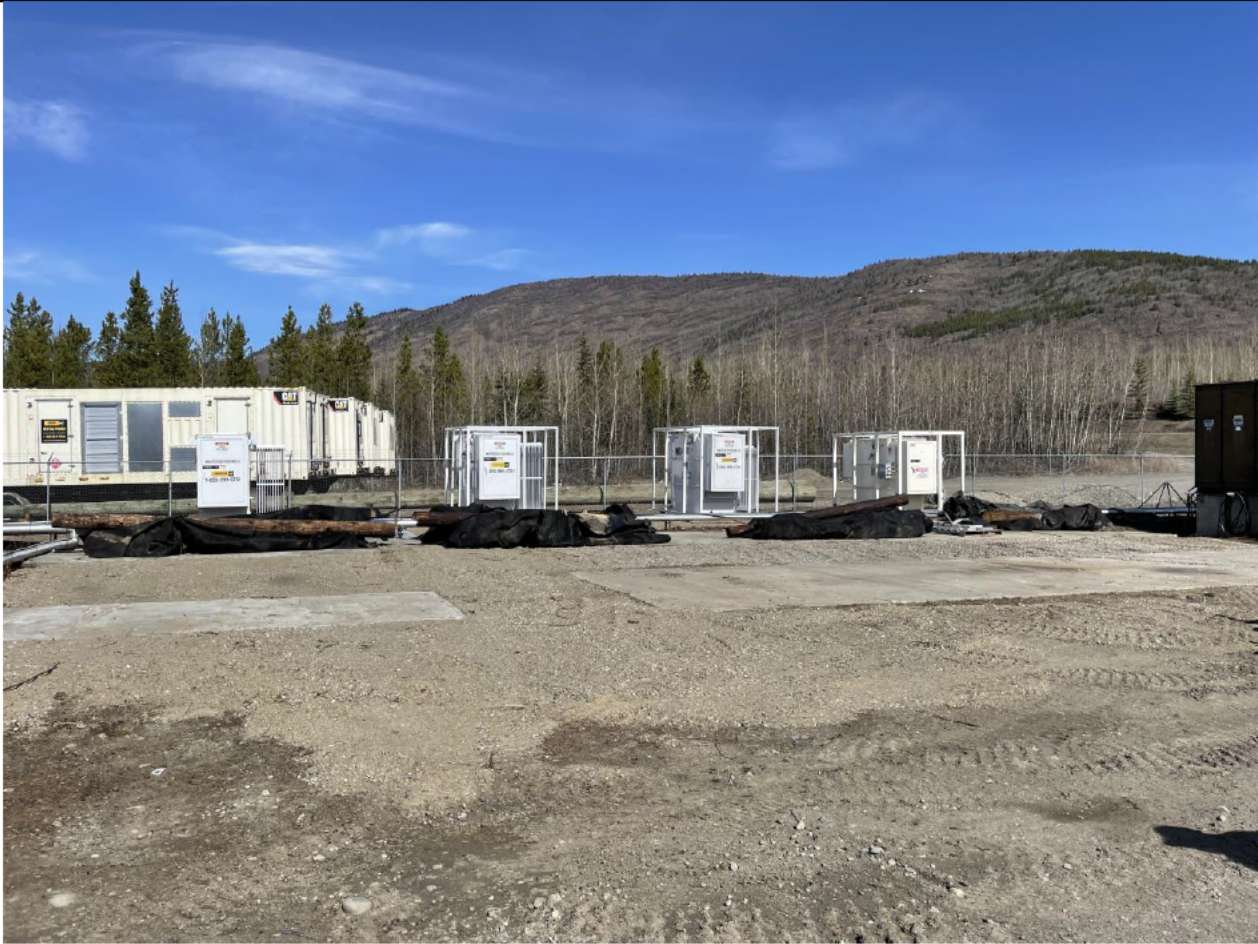
- Site inspection indicated that 4 of the rental generators (YM26-T1, YM25-T1, YM24-T1 and YM22-T1) had been move from location and construction to set them up in another location was underway. (Figure:1)

Figure 1: Site of 4 new rental generators.

1. Permittee is requested to follow-up with regards to site changes, this includes decommissioning of generator FD-1, and the change in location of generators YM26-T1, YM25-T1, YM24-T1 and YM22-T1, as well as any other anticipated development or changes that may be occurring as required by permit. **Please follow up with Elizabeth Barker, environmental protection analyst at Elizabeth.Barker@yukon.ca.**
2. Permittee is requested to brief and make operators aware of the full complaint management system in place.

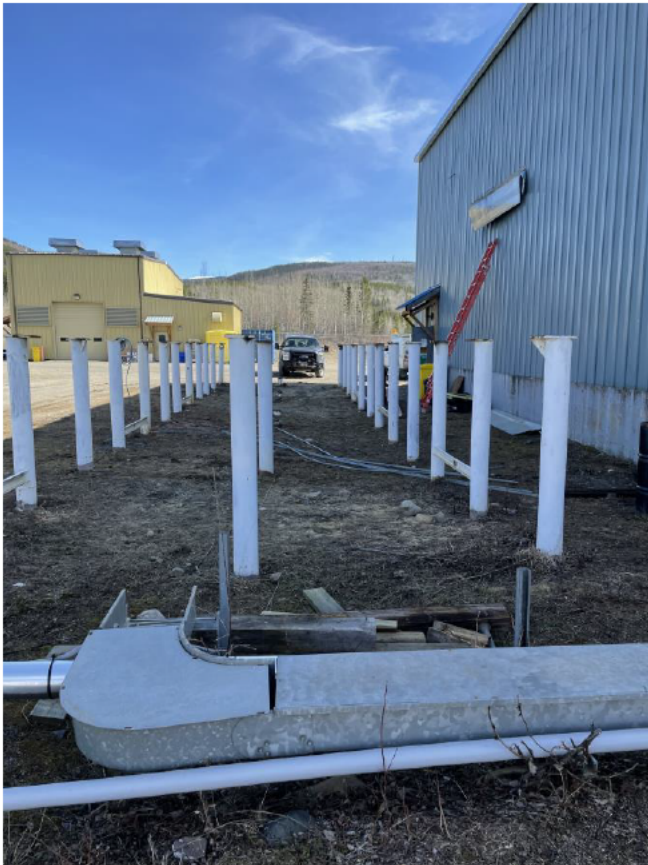
- Permittee appears to be compliant with condition 7.1 with regards to unauthorized emissions, and reporting.
 - JONES said there have been no unauthorized releases and that they have internal protocols for any spills that occur.
 - Reported spill 22-056 is still in the process of being remediated as ground is still frozen. (Figure: 2)

Figure 2: Spill 22-056 area.

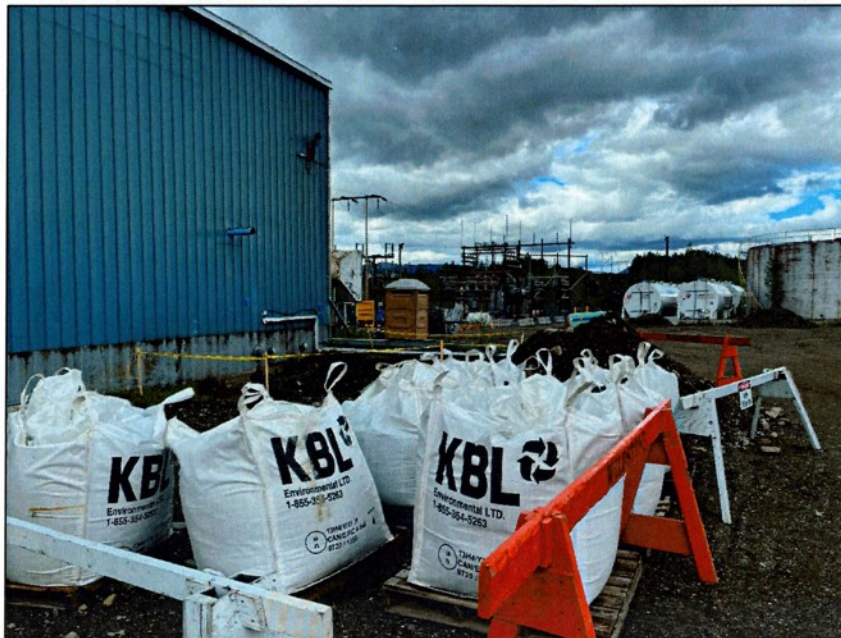
Figure 1: Site of spill 22-056 remediation efforts not yet complete on June 27, 2023.

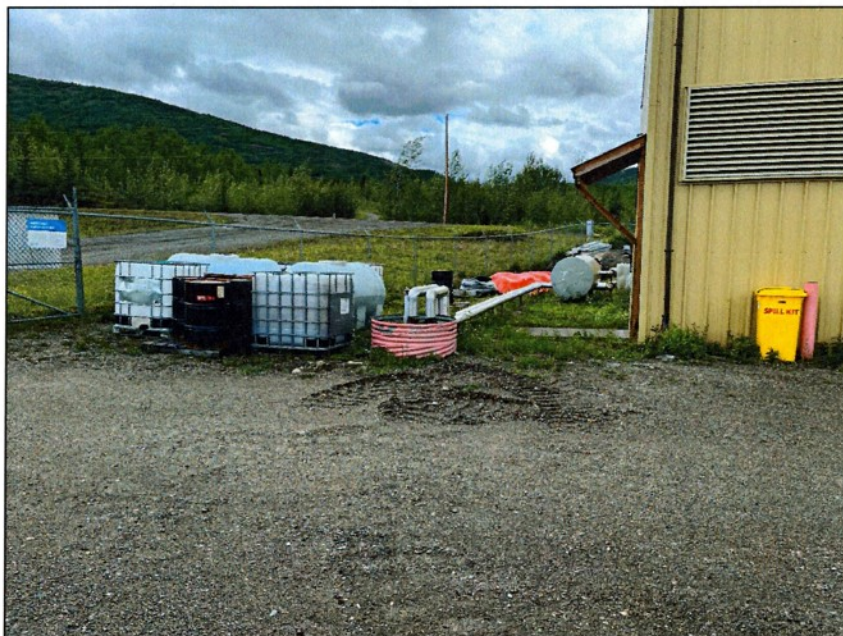
INSPECTION COMMENTS
<p>On June 27, 2023, the undersigned environmental compliance officer, met with Gary JONES at the Yukon Energy Corporation's (YEC) Faro Generation Station conducted an inspection of air emissions permit 60-010-01. At time of inspection no generators were in operation and all electricity was being generated via hydro.</p> <p>*1 The spill (report 22-056) that occurred on July 6, 2022 and resulted in glycol coolant on the ground was being remediated at the time of this inspection (Figure 1). Excavation of contaminated soils began on or about June 13, 2023.</p> <p>*2 Observations of cubic totes containing glycol coolant on June 27, 2023 were found to be uncovered and sitting in the open (Figure 2). It was conveyed to Operations Manager JONES, these totes should be secured and covered to prevent spills.</p> <p>No other concerns were observed.</p>

Figure 2: Glycol coolant stored uncovered and unsecured.
