# Microplastic monitoring in the Yukon River

## Microplastic monitoring

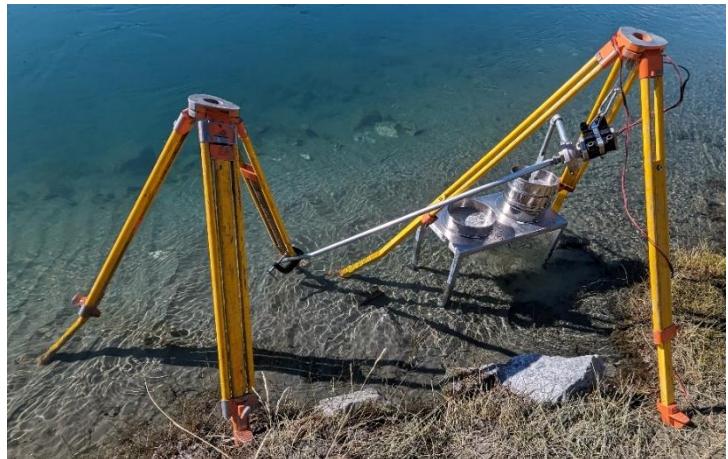
Figure 1. The sampling equipment set up in the Yukon River. The pump is suspended from two wooden tripods, positioning the intake on the upstream side and the outlet over the filter sieve, downstream of the intake to avoid recirculating water.

The ASTM D8332 sampling system is low-impact and allows for the filtration of very large volumes of water – thousands of litres – over a long period of time. Stirring sediment and eroding banks are deliberately avoided, and only about 500 ml of water is taken from site, which is needed to rinse the filtered material from the sieve into a jar. The intake is a single 3/4-inch pipe that is equipped with an intake screen to prevent fish ingress or damage.

The sample collection system is fully portable, easy to use and virtually plastic-free. It is inexpensive, simple to build and can be used by anyone. The materials used and the sampling design deliberately avoid plastic to reduce potential contamination. Sampling takes only a few hours and mostly involves monitoring the pump for malfunction.

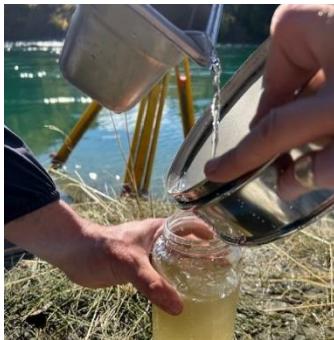
Figure 2. Back rinsing sieve to collect the sediment into sample jars.

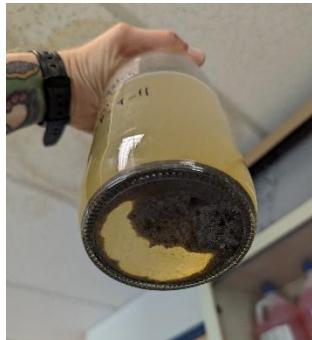
Figure 3. Sediment sent for analysis representing several thousand litres.
