# Water Audit Report

## Eagle Plains Lodge

### MN07-075-2

October 6, 2026

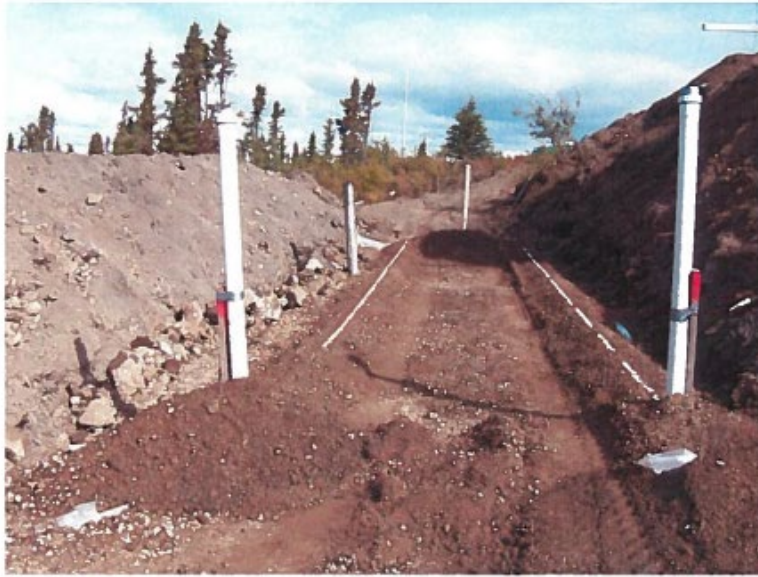
Photo 1. Taken from Waterline as-built documents (EBA, 2008), and described as “placement of 40mm crushed gravel mounded on either side of the PVC pipe prior to placement of geotextile (August 18, 2008)”.

The treatment facility is contained within a fenced-in structure, approximately the size of four Sea Cans. The as-built diagrams of the in-ground workings include photographs and show construction of the underground rock pit and the 150 mm perforated PVC pipe, through which effluent discharges to ground at a slow and variable rate. It is difficult to speculate the exact flow rate of the effluent discharge, as it likely corresponds to the water usage and treatment plant’s operational cycles. The facility operator informed WSS that a small amount of settled sludge is removed once a year,

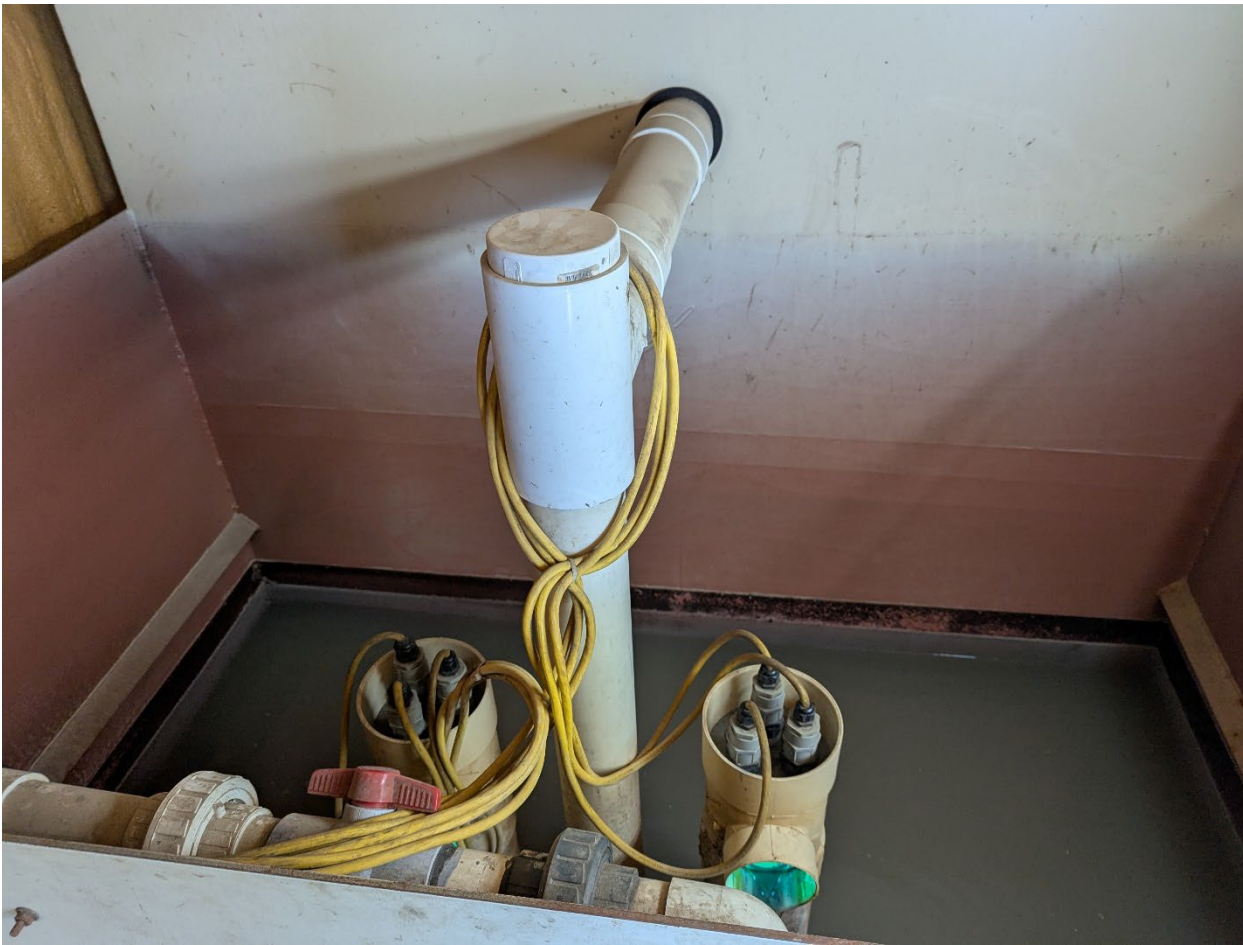
It is likely that the effluent sampling location was set up for practical reasons (i.e. this is the last physically accessible location before discharging to the rock pit) and considerations should be made when interpreting water quality data. When a sample is collected from the current effluent sampling

location (Figure 4) it is recognized that once it has left the mechanical treatment facility, it is still being deliberately discharged to the buried rock drain.

Figure 4. Inside the treatment plant where effluent sample is collected. UV lights inside white pipes attached to yellow wires.

The mechanical system installed at Eagle Plains Lodge was provided by Pinnacle Environmental Technologies, who also installed and ran verification processes for the treatment system (Access Consulting Group, 2009). Water enters the facility into a pre-aeration chamber where minimal treatment occurs by way of aeration and settling. Next, the effluent moves to the “Trash Collection/Settling Chamber” designed to properly settle and attenuate solids and other physical debris that can be removed by rudimentary screening processes. After travelling through a pump chamber, the effluent reaches a Fixed Activated Sludge Treatment (FAST) chamber that used microbial films and aeration to remove organic matter from effluent via biological oxidation. This chamber also produces some amount of solid/sludge material, which all ultimately gets removed from the system approximately once a year by truck. This process is intended to produce relatively high oxygen water with the only other byproduct being carbon dioxide. The final step of the mechanical treatment process is the UV & Discharge pump bay (Figure 4).
