Please find the report of VGCX's preliminary investigation results regarding the January 6, 2024 'fall of ground' on the 1065 m elevation of the HLF.

> *OFFENCE DESCRIPTION*
>
> *A fall of ground event took place on the southeast corner of the Heap Leach Facility on January 6, 2024. In accordance with Part 3, Section 60 (2)(d)(i) of the Workers' Safety and Compensation Act, Workplace Health and Safety is requesting a completed investigation report for this incident.*
>
> *WORKERS' SAFETY AND COMPENSATION ACT*
>
> *60*
>
> *(2) Without limiting subsection (1), an officer may*
>
> *(d) make any examinations, inquiries, inspections, and investigations that the officer considers necessary*
>
> *(i) to determine the cause and particulars of any incident or of any injury to or death of a worker, or*
>
> *CORRECTIVE MEASURES*
>
> *The Mine Manager shall provide a finalized investigation report for this incident.*
>
> *Provide all supporting documentation and/or photographs related to the investigation of this incident to the issuing Safety Officer.*

PHLF January 2024 Internal Ore Bench Slide Preliminary Assessment and Recommendations

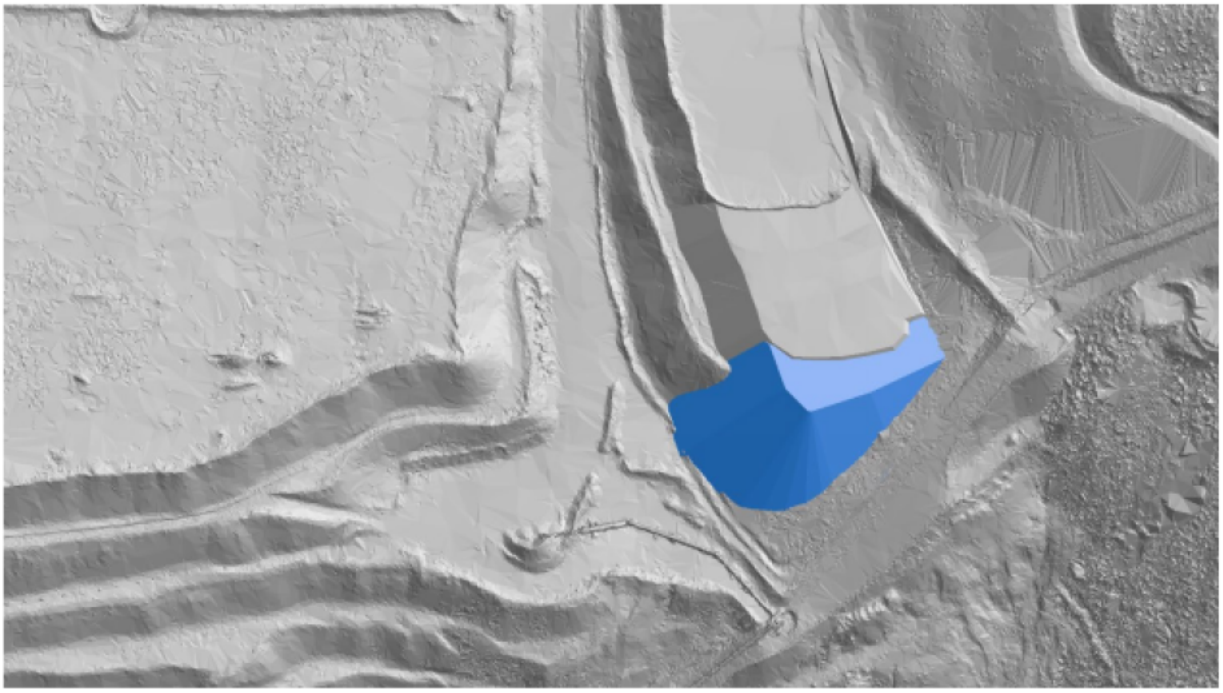
Figure 1 below shows the planned heap bench build out prior to the incident. Ore placement in this area was occurring at the time of the slide.

Figure 1: The blue shaded area shows the planned build out prior to the slide.

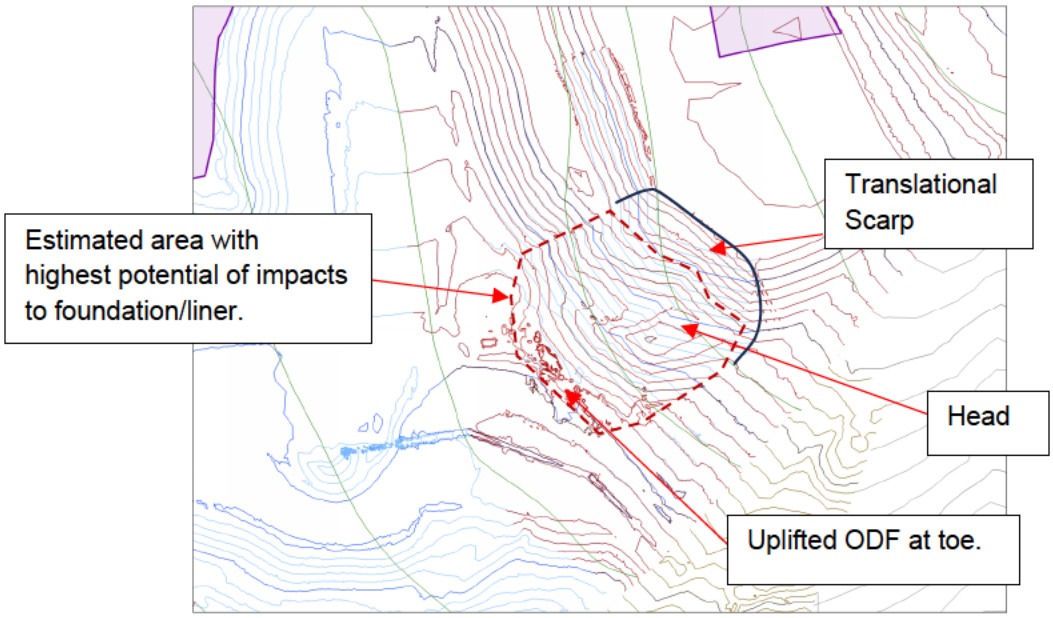
The surface after the ore slide is included in ***Figure 2*** and ***Photograph 1***. Based on the photographs provided by VGC and a preliminary analysis of the post slide topography the slide appears to be a block-type slide (i.e. translational and not rotational). This suggests that the impacts to the foundation and liner may be limited to the base of the newly stacked area and the extent of the final slide toe. However, the extent and severity of these impacts cannot be known until the liner in this area is uncovered and evaluated. Due to the potential of leakage of leachate solution through the geomembrane and GCL into the underdrains from this ore slide, Forte believes a conservative approach to evaluating the extent of impacts to the liner system and foundation is warranted. Forte has made a preliminary estimate of the likely extent of potential impacts by projecting the limits of the observed head scarp at the top of the slide area to the liner grade elevation assuming the upper portion of the failure block is oriented at a slope that can be approximated by the Rankine Active critical slope angle (W.J. Rankine, "On the Stability of Loose Earth" published in 1856). This is a common assumption when performing block-type analyses, with the upper (driving) end of the failure surface oriented at:

Failure Angle (from horizontal) = $45^o + (\varphi/2) = 45^o + (38^o / 2) = 64^o$

This equation was used to estimate the approximate inclination at which the sliding mass likely initiated its descent (64^o) to the liner elevation. In the context of material movement with a concealed slide angle toe, applying this equation allows for an educated estimation of where the failure plane intersects with a weaker

layer, in this case, the liner surface. Based on these results the area with the highest potential of impact to the liner is presented in ***Figure 2***.

Figure 2: Area after slide.

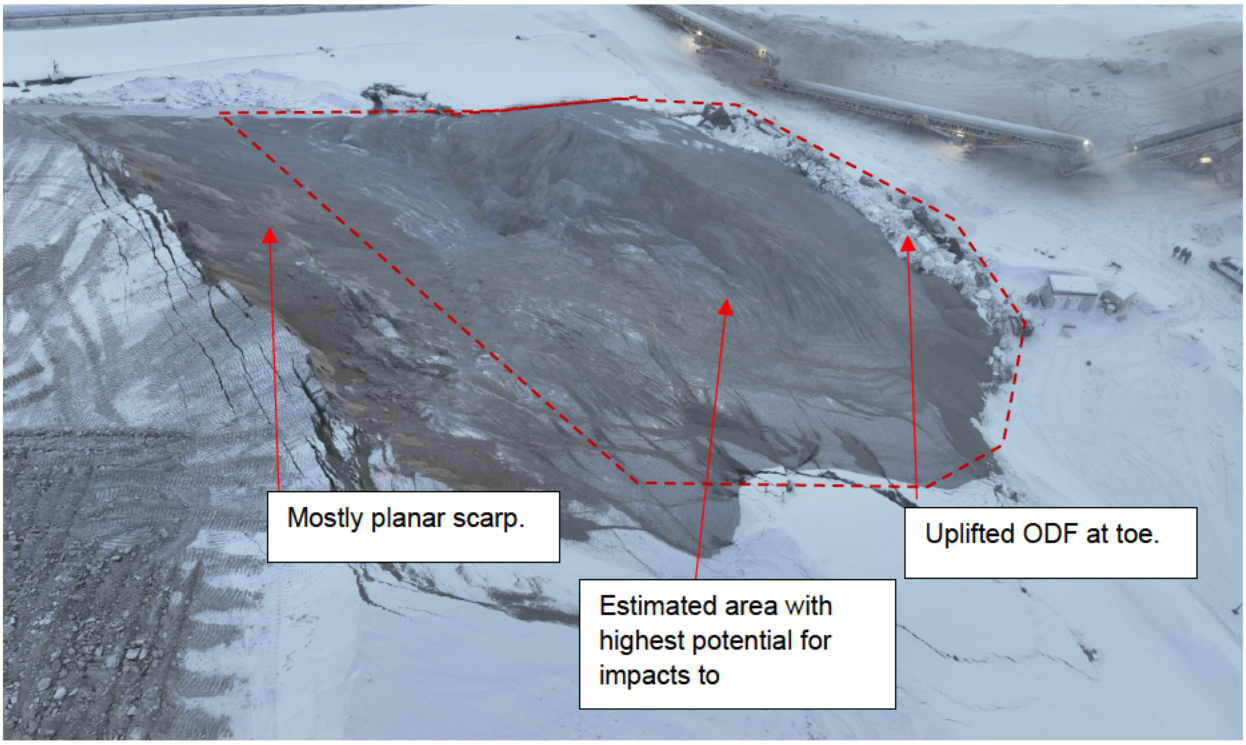
Photograph 1: Photograph of slide. Photograph facing southeast.

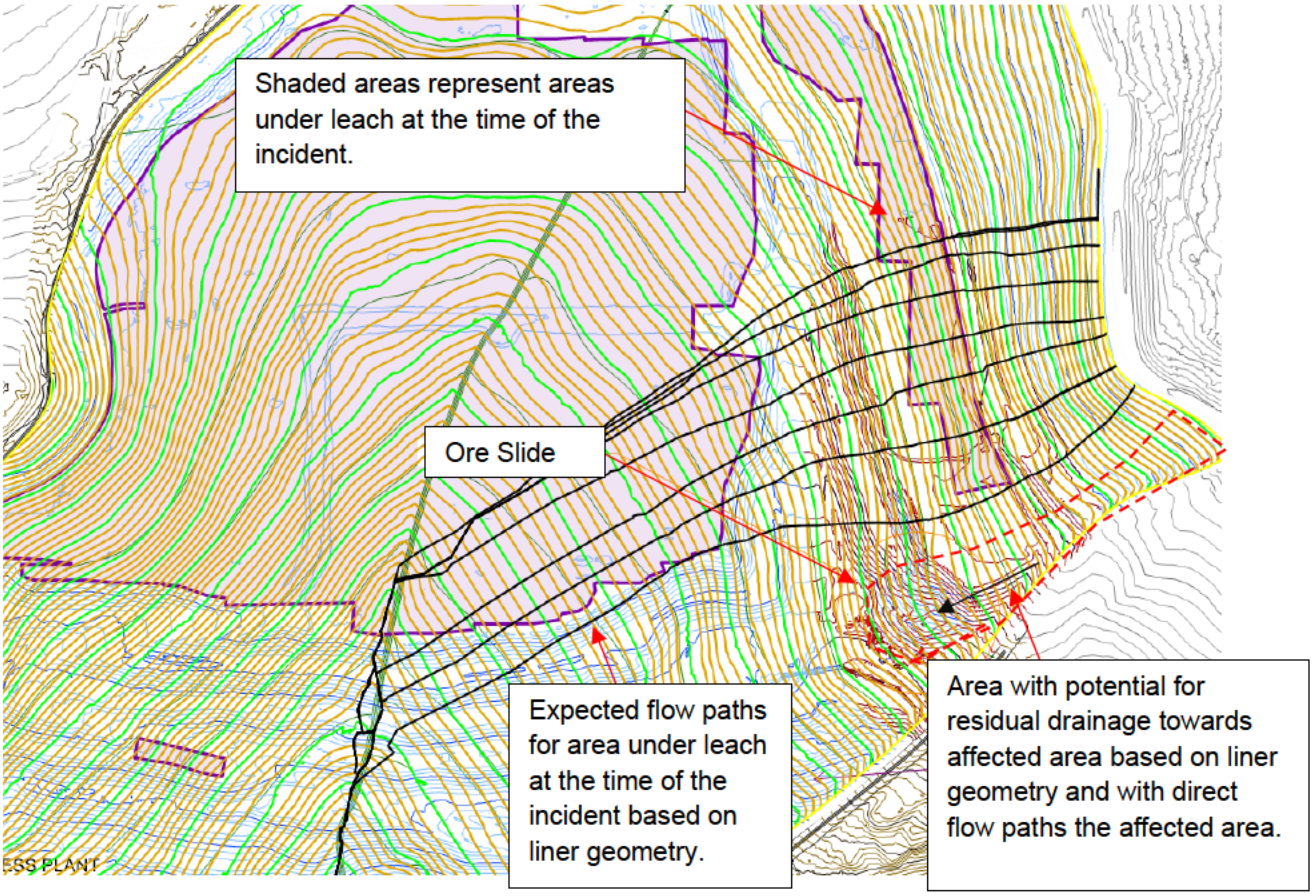
VGC provided Forte with a figure showing the areas of the PHLF that are currently under leach. Forte analyzed subgrade as-built information to determine flow paths in areas around the slide. Given the current leaching regime it is expected that leachate solution would not flow to the affected area based on the topography of the liner surface (***Figure 3***). However, residual drainage may be experienced from existing benches which were recently under leach. Anticipated paths are include in ***Figure 3***. It should be noted that these flow paths were generated using Civil 3D's Waterdrop command which simulates flow of water over a open topography. It is presented here to show the general direction of flow. However, as fluid flows through the ore and ODF it will spread laterally through the ore due to capillarity and pore pressures as the fluid is added to the heap surface.

Figure 3: Subgrade contours and expected flow paths based on liner geometry.

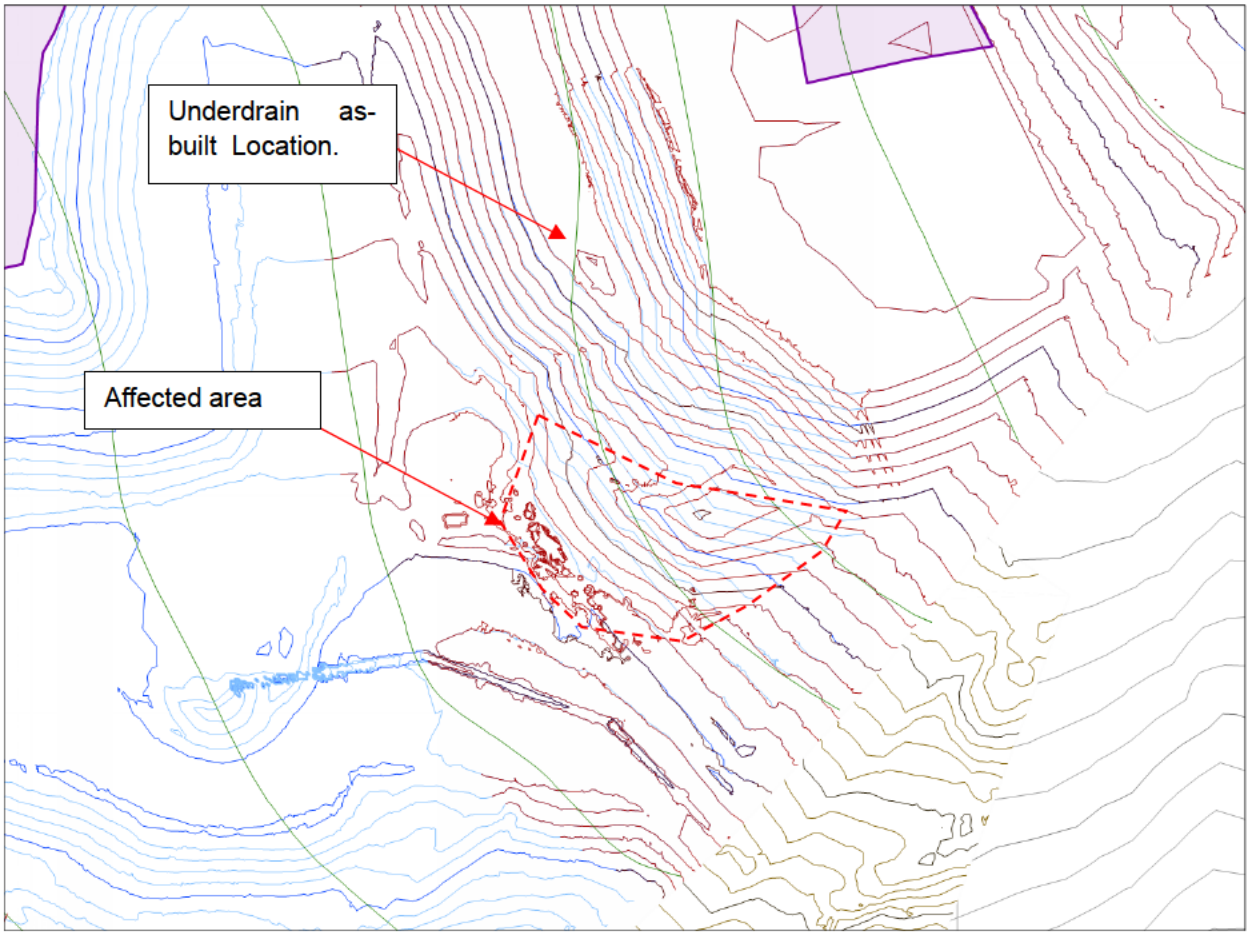
Pregnant Leachate Solution (PLS) piping installed in the ODF exists under the area of the slide and has likely been disturbed or damaged. Future investigations will be used to evaluate the extent of the damage. Underdrains exist below the liner surface in the subgrade. It is unknown if these underdrains were damaged during the slide. The underdrain locations relative to the slide are shown in ***Figure 4***.

Figure 4: Underdrain as-built location in the area of the slide.

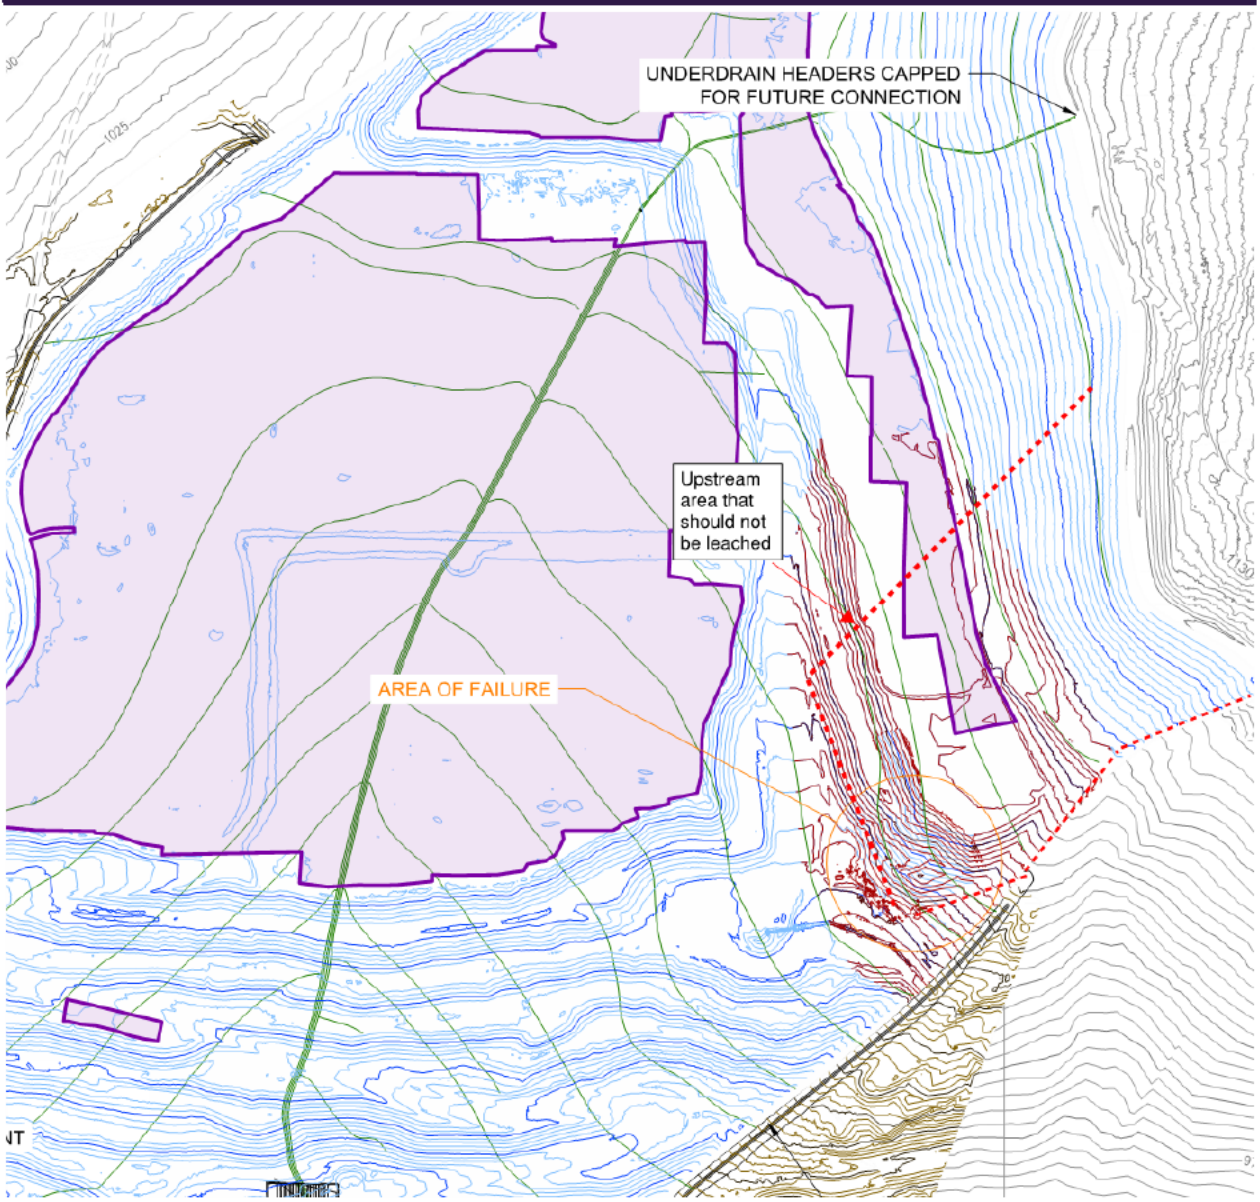
As discussed above, applied fluid is expected to spread laterally in the ore and ODF from the active leach area. The exact geometry of lateral spreading is not known, but is typically affected (increased) by horizontal low-permeability layers, anisotropy of permeability, and partially-saturated conditions within the ore zone. Additionally, two underdrains are present in the potentially affected area (See ***Figure 4***). Therefore, Forte believes that a buffer zone should be maintained around the slide where leaching is avoided to prevent lateral migration of PLS to any potential holes in the liner. As a conservative approach Forte developed a minimum lateral buffer of 100m and relative to any flow paths that could lead to the affected area. The buffer zone is included in ***Figure 5***.

Figure 5: Upstream area that should not be leached.

- Leaching in areas that were within the buffer were halted,
- Leaching will not take place within buffer until the EOR has completed their assessment.
- Monitoring water quality and physical stability of the area is ongoing as discussed in Section 3.
- Based on the ongoing investigation, and in consultation with the Forte Dynamics representative when he attends site, the requirement for liner repair will be established if necessary.
- Status reports for the advancement of planning and execution of this work will be provided to YWHSB as it becomes available.

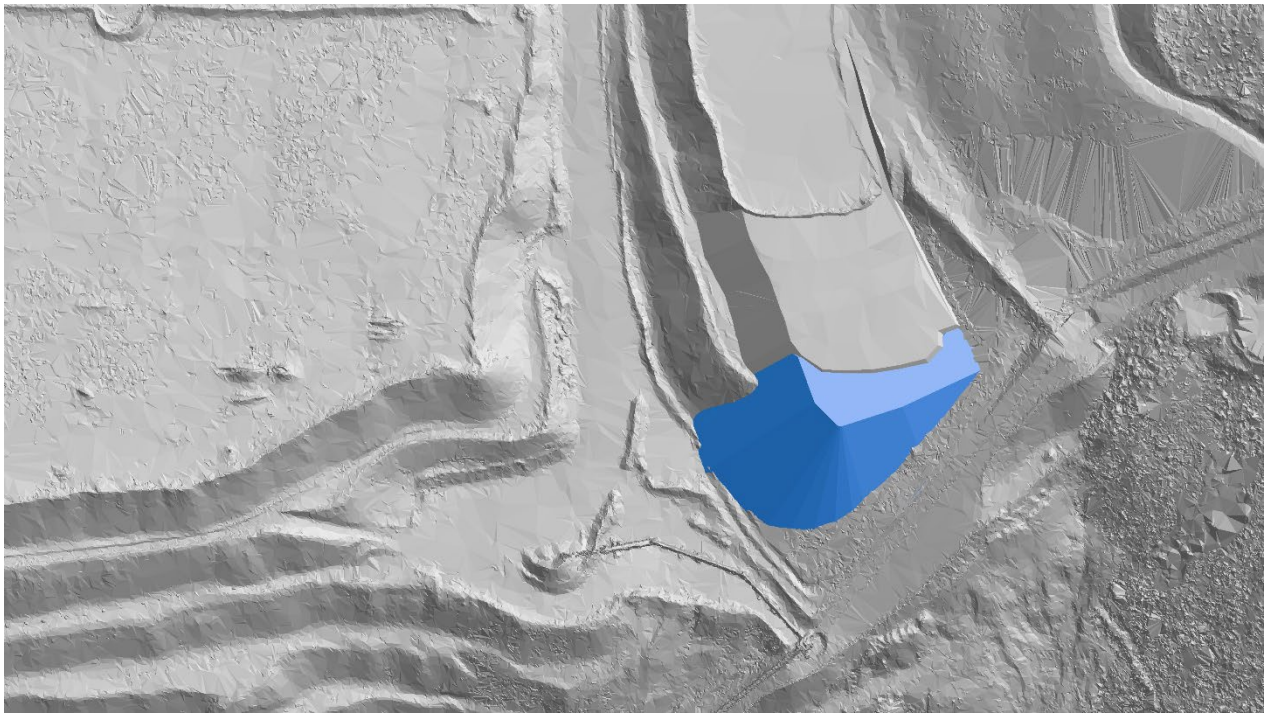
Planned Stacking Extents using January 4th Surveyed Surface.

On January 3rd, concerns regarding safe operation of the active 1065 lift were brought up by the planning group. The lift had a portion that was up to 33 meters in height due to the geometry of the area. It was brought forward that to safely advance in the area, trucks were to dump short, and the dozer push the material to the crest. This message was conveyed to all supervisors and crews during the toolbox meetings. Active leaching progression in the area was delayed until the final stacking limits were to be achieved. The overall planned stacking limits are viewed in the following figure.

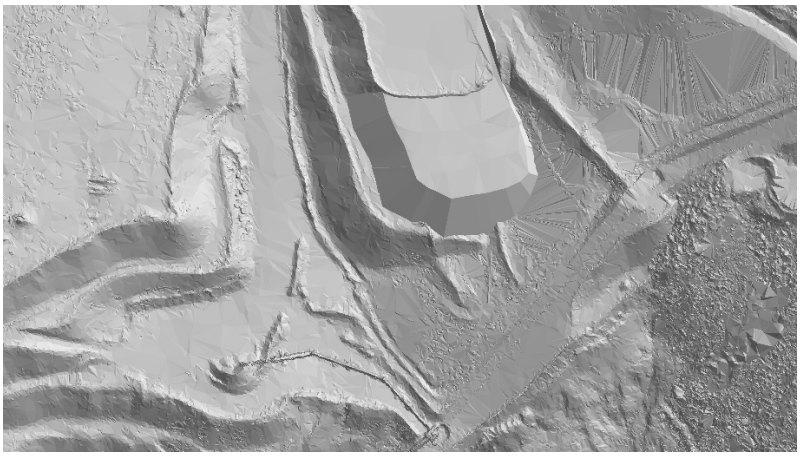
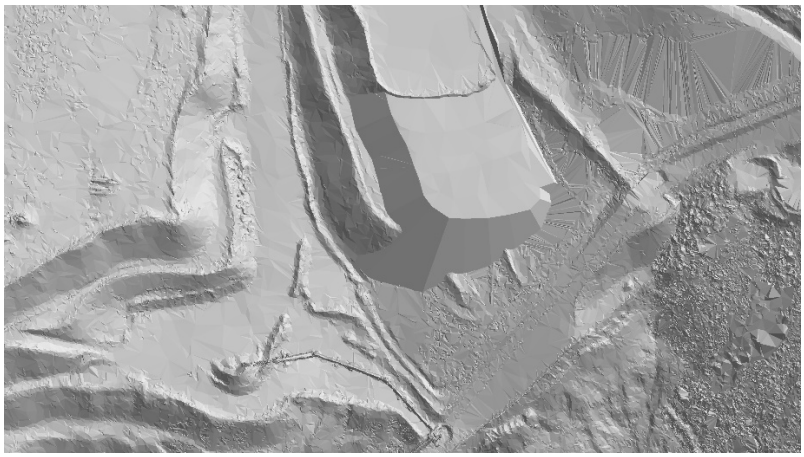
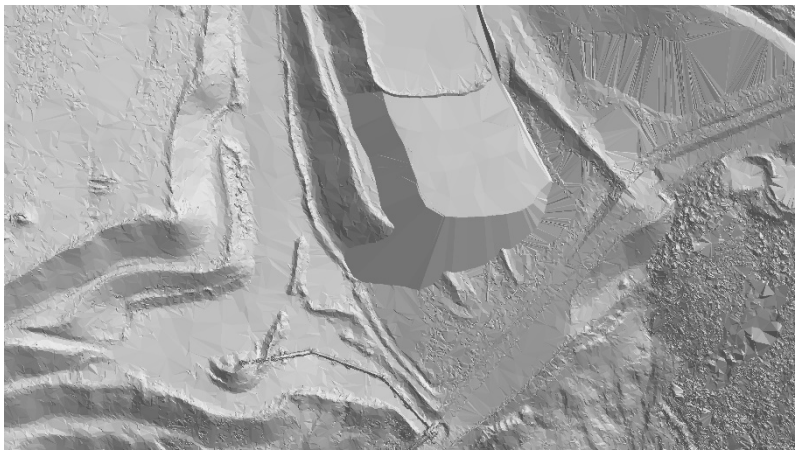
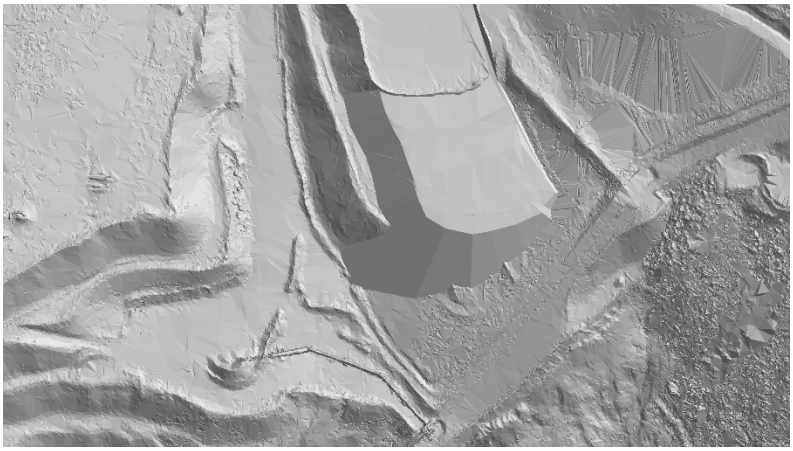
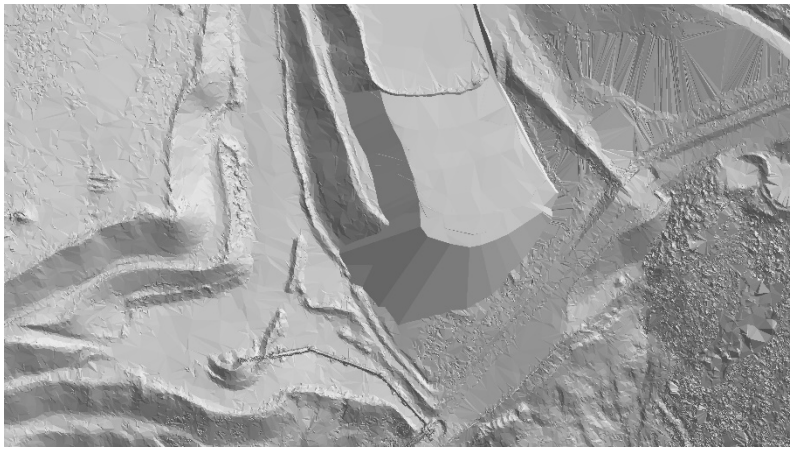
The following figures display the progression of the area leading up to the failure on January 6th.
